Advance Confidential Report E4L27

AN ELECTRON AND X-RAY DIFFRACTION INVESTIGATION OF SURFACE
CHANGES ON NITRIDED-STEEL PISTON RINGS DURING ENGINE
OPERATION IN NITRIDED-STEEL CYLINDER BARRELS

By J. N. Good and L. O. Brockway

Aircraft Engine Research Laboratory
Cleveland, Ohio

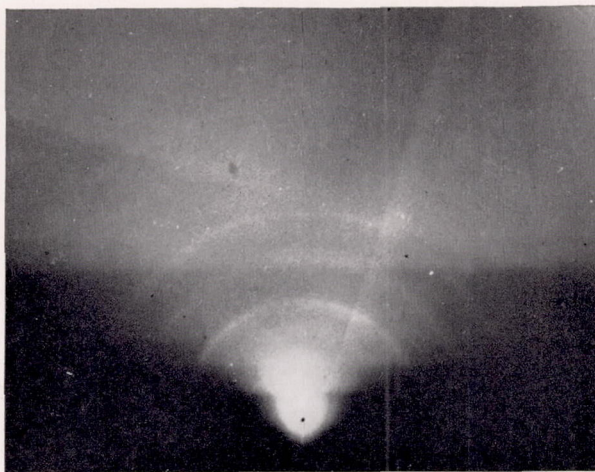
Figure 3.—Electron-diffraction pattern from the surface of a new nitrided-steel piston ring. This pattern of α -iron was obtained after the surface had been microscopically ruled with 8,000 parallel lines to the inch. $\times 3$.

In order to avoid extremely smooth surfaces on specimens subjected to electron-diffraction examination, the running faces of both new and used piston rings were roughened on a microscopic scale by abrading, etching, ruling, etc. In the case of new rings, the electron-diffraction patterns from the surfaces after (1) abrading with emery, (2) etching with 2 percent nital, (3) ruling with the diamond-point ruling machine, or (4) heating to 700° or 800° F in a vacuum, all showed a strong set of diffraction lines corresponding to the α -iron diffraction pattern, together with a few extra lines that corresponded to some of the stronger lines of Fe_3O_4 . (The three strongest lines of the Fe_3O_4 pattern are given in table I as listed in the A.S.T.M. file of X-ray powder diffraction data, although this oxide cannot be distinguished from $\gamma\text{-Fe}_2\text{O}_3$ (reference 3.) Considerable variations occur in the sharpness of the lines and the intensity of the background, the best pattern being given by the ruled piston ring (fig. 3) and the poorest (although still recognizable) by the heated piston ring. Figure 4, for example, shows the results of abrading with emery paper in comparison with figure 3.
